# MID SUSSEX DISTRICT PLAN

## SAFETY STUDY

<b>Client/Project owner</b>	Mid Sussex District Council
<b>Project</b>	Mid Sussex District Plan
<b>Study</b>	Safety Study
<b>Type of document</b>	Report
<b>Date</b>	30/09/2024
<b>Reference number</b>	GB01T24C55/RPT/01
<b>Number of pages</b>	84

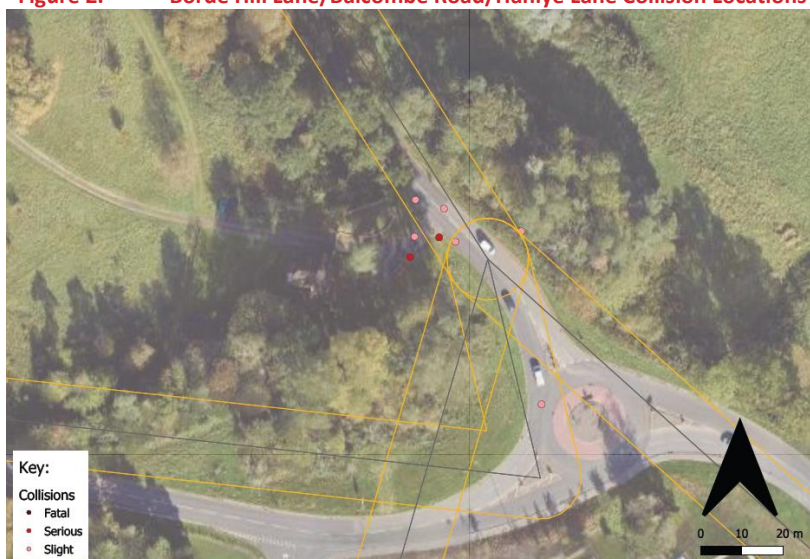
**Figure 2. Borde Hill Lane/Balcombe Road/Hanlye Lane Collision Locations**

2.2.7 As is evidenced above, it is clear that the majority of collisions occur on Borde Hill Lane to the north of the junction, and the causation of a majority of the collisions is associated with careless or reckless driver behaviour, including failures to look for other drivers. The frequency of accidents has reduced since the upgrade scheme was built out.

- 2.2.11 Due to the recent upgrade scheme to an unsignalized roundabout in 2020, and the limited physical improvements which are feasible being considered unlikely to have a significant effect upon the observed causes of collisions at the junction, this location has not been taken forward for future mitigation.

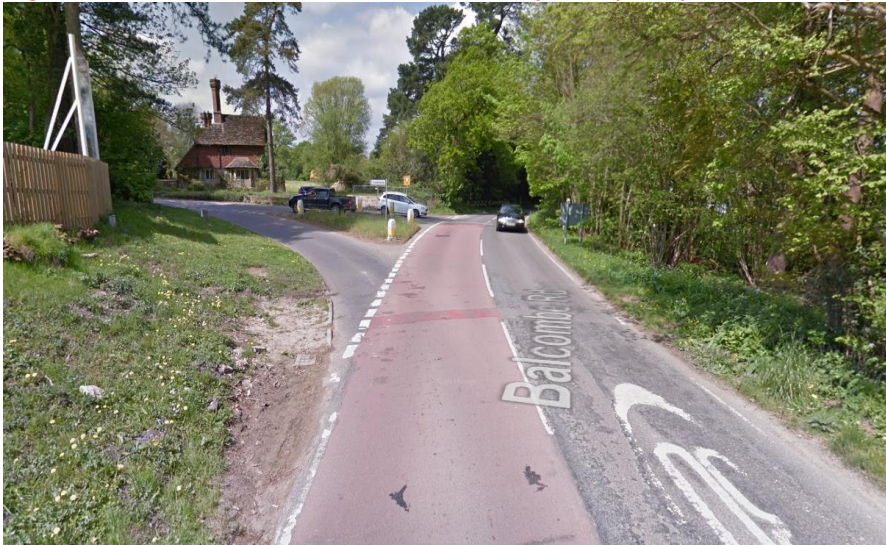
**Figure 3. Borde Hill Lane/Balcombe Road/Hanlye Lane pre-September 2020 layout**

2.2.8 The previous junction layout is indicated in **Figure 3** below. This previous layout is evident to have featured faded road markings, surface degradation, and a short entry lane into Hanlye Lane to the west for use if travelling northbound along Balcombe Road.

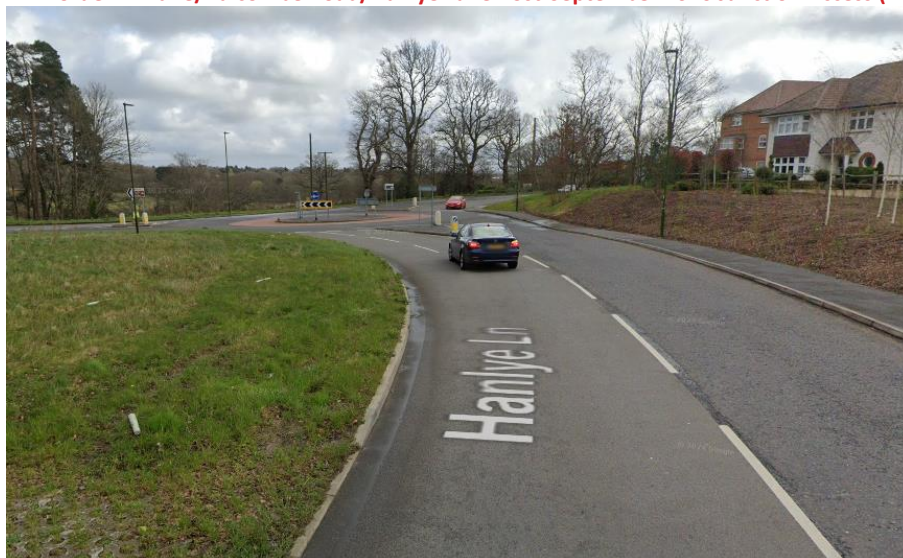
**Figure 5. Borde Hill Lane/Balcombe Road/Hanlye Lane Post-September 2020 Junction Access (Western Arm)**

2.2.9 Upon closer analysis of the junction layout post-September 2020, it is apparent the arms have wide entries to the roundabout circulatory, and lighting is present around the junction. Whilst all three arms are comprised of two entry lanes, it is noted that along the Borde Hill Lane arm to the north, the lane markings for two lanes stretches approximately four metres in length from the Give Way line allowing for a single car flare. The view from the Balcombe Road arm is indicated in **Figure 4** below, and the lack of signage on the approach arm from Hanlye Lane is displayed in **Figure 5**.

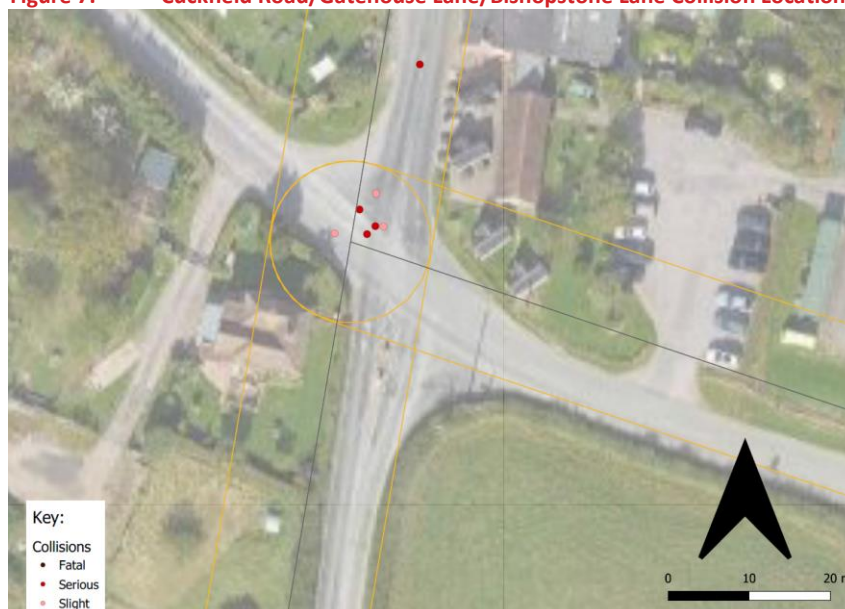
**Figure 7. Cuckfield Road/Gatehouse Lane/Bishopstone Lane Collision Locations**

2.3.6 As evidenced above, all collisions from the 2017-2023 study years are noted to have occurred between the north and western arms of the junction. Through analysis of the specific collision data, three of the collisions are noted to be the result of vehicles travelling along Cuckfield Road failing to give way or see oncoming vehicles travelling east-west along Gatehouse Lane/Bishopstone Lane.

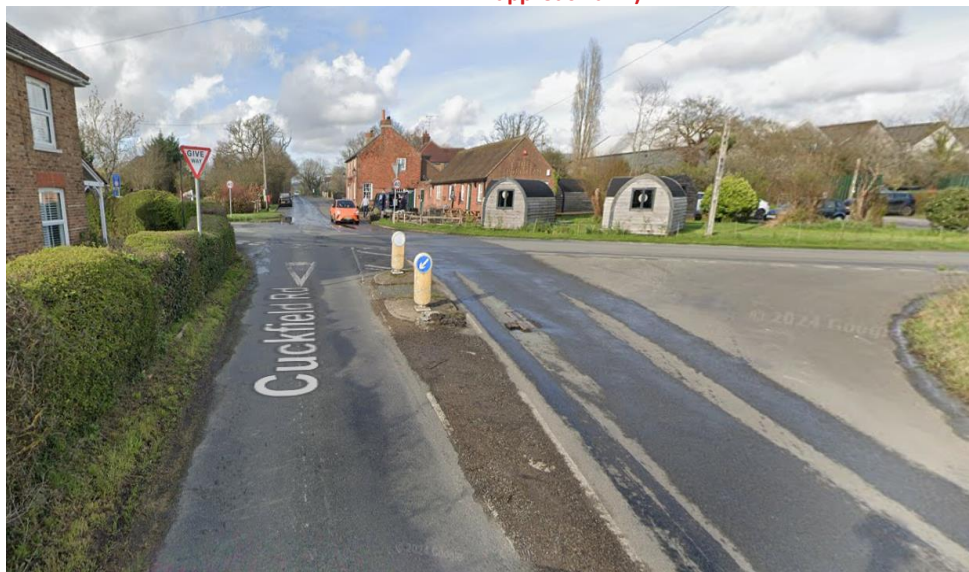
**Figure 8. Cuckfield Road/Gatehouse Lane/Bishopstone Lane junction layout (View from Cuckfield Lane South approach arm)**

- 2.3.8 As is evident from the figures above the junction is subject to significant degradation, with the southern arm of Cuckfield Road specifically comprised of a narrow entrance to the junction, with faded road markings, and heavily-worn road surfacing.
- 2.3.9 Whilst it is apparent that the road surfacing along Gatehouse Lane and Bishopstone Lane is in better condition than along Cuckfield Lane North and South, visibility to the east and western arms from the north and south arms is limited, as displayed in **Figure 8** above.

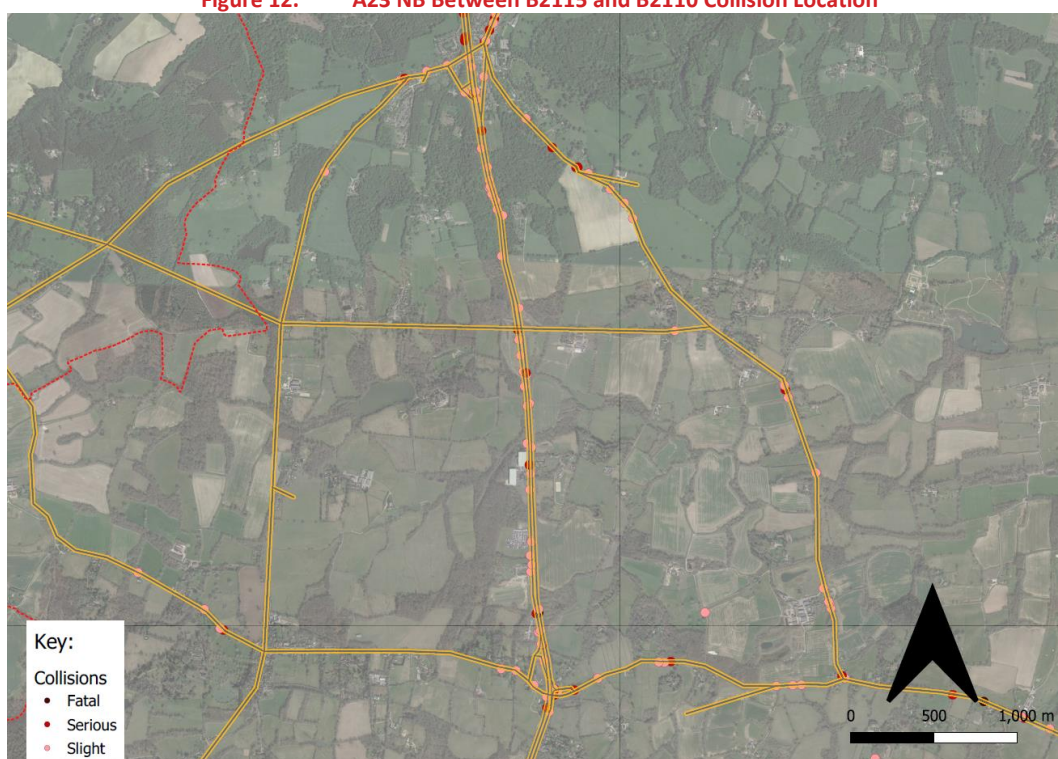
**Figure 12. A23 NB Between B2115 and B2110 Collision Location**

2.4.6 As is evidenced above, the collisions occur relatively evenly throughout the length of the link, with a common theme across the collision data seen to be the result of vehicular slowdown and subsequent crashing into the rear of vehicles. Additional causation is seen as wet weather, with five collisions caused by loss of control due to surface water.

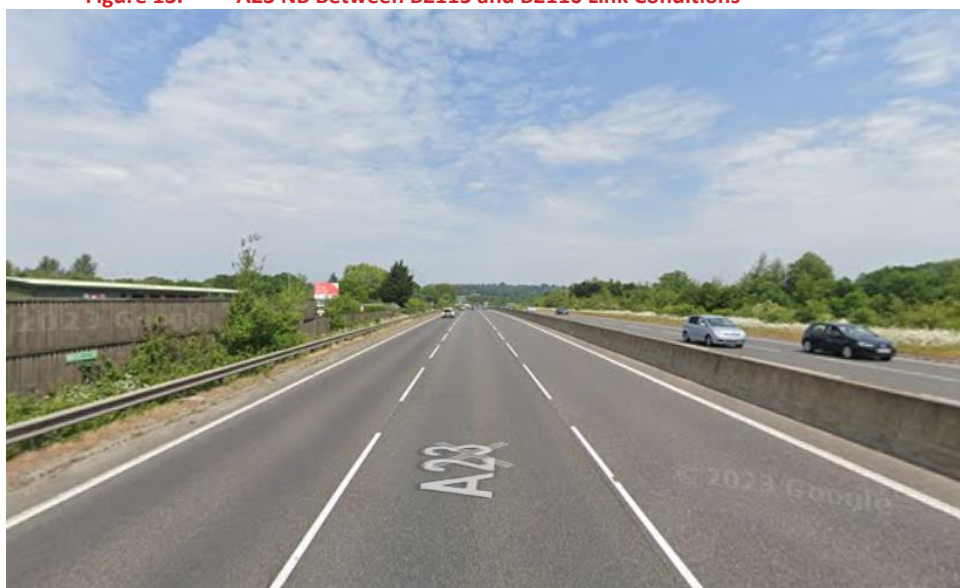
**Figure 13. A23 NB Between B2115 and B2110 Link Conditions**

- 2.4.8 As is evident from the image above (which is representative of the link as a whole), the link is noted to be of a smooth surface quality, with wide lanes and adequate lighting. With all aspects of the link considered, it is determined that much of the causation behind the link's inclusion within the collision ranking is due to its length, with the causation behind many of the collisions being due to bad weather conditions. We have additionally considered the drainage provision on this link, due to the number of incidents associated with wet weather; we have not identified any specific issues which we consider would be directly associated with the drainage conditions.

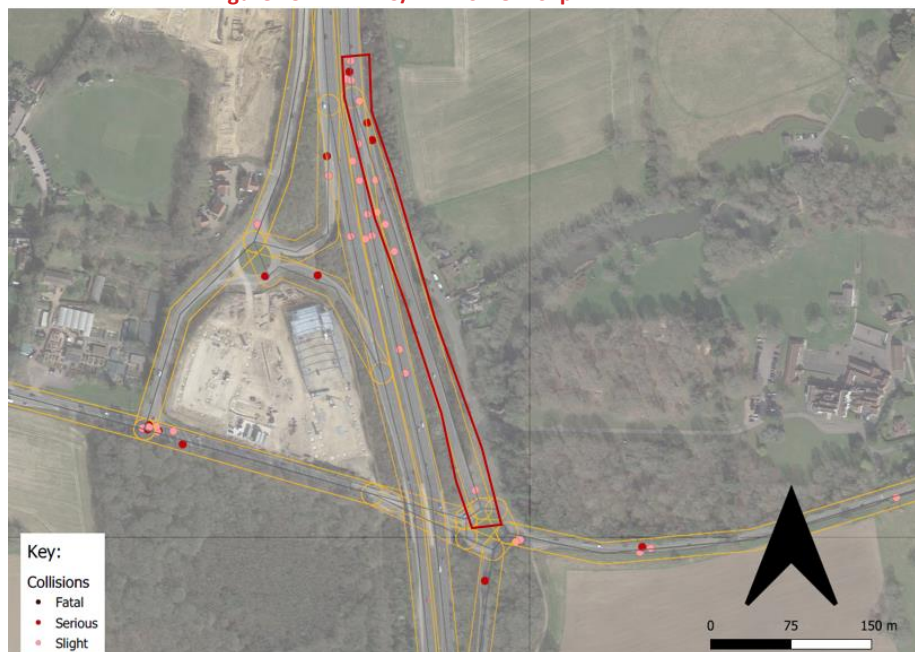
Figure 15. A23/A272 SB Off-Slip

2.5.7 As depicted above, seven of the twelve collisions are noted to occur within proximity of the point of diverge from the A23, with the remainder largely occurring at the northern end of the off-slip with one collision slight in severity occurring in close proximity to the roundabout at the southern end of the slip road.

2.5.8 Of the reported collisions, eleven occurred in dark and/or rainy conditions, whilst one occurred in damp daylight conditions. The majority of the collisions were caused by reckless driving, whilst two collisions were caused by drivers failing to notice stationary cars in front of them whilst accessing the off-slip.

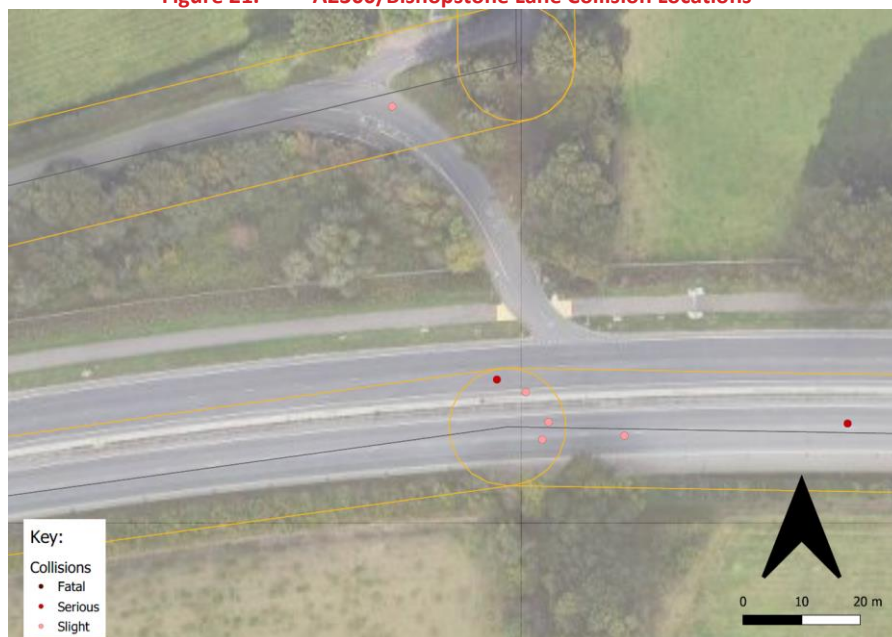
**Figure 21. A2300/Bishopstone Lane Collision Locations**

2.6.6 As is evident, five of the collisions (one serious, four slight) occurred at the junction itself, whereas one serious collision occurred to the east along the A2300, and one slight collision occurred to the north on Job’s Lane.

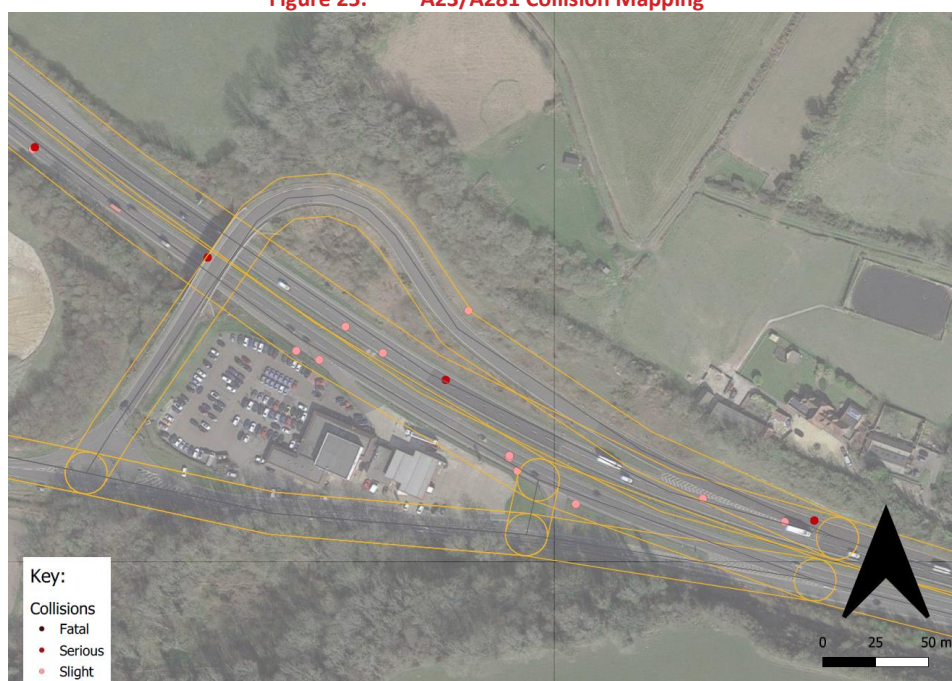
**Figure 25. A23/A281 Collision Mapping**

2.7.5 As indicated above, three of the collisions (one serious, two slight in severity) occurred in close proximity to the merge with the A281, whereas the other serious collision occurred on the spread out throughout the length of the merge.

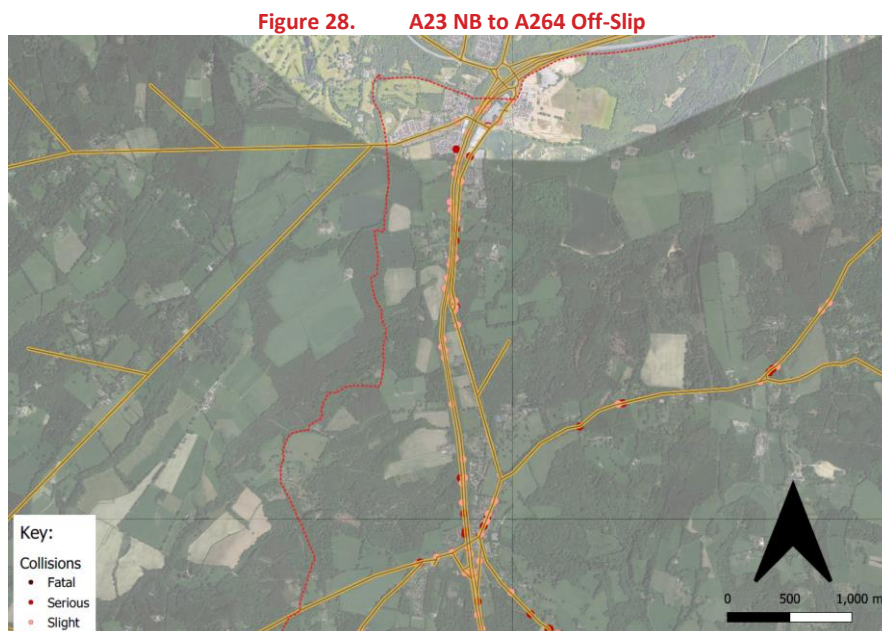
2.8.6 As is evidenced above, four of the nine noted collisions are the result of drivers losing control of vehicles in wet or icy conditions. Collisions are noted to have occurred relatively evenly along the link.

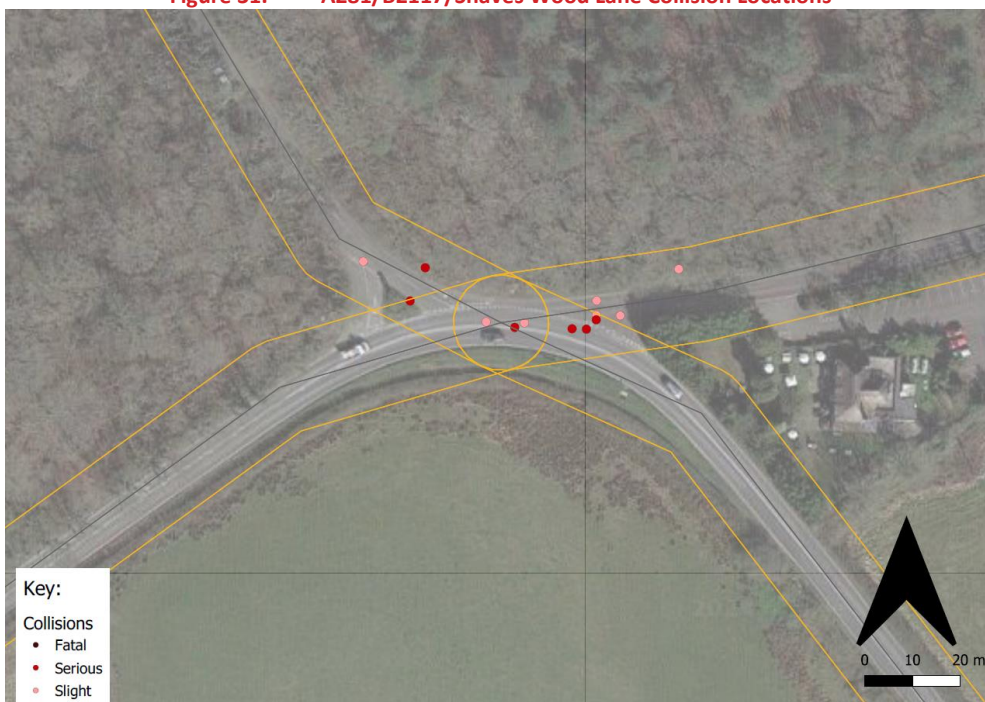
**Figure 31. A281/B2117/Shaves Wood Lane Collision Locations**

2.9.7 As seen in the figure above, the majority of the collisions occur to the east of the junction, with six collisions (three serious, three slight) occurring at the B2117/A281, three collisions (two serious, one slight) occurring to the west at the Shaves Wood Lane/A281, and three collisions (one serious, two slight) occurring within the centre of the junction.

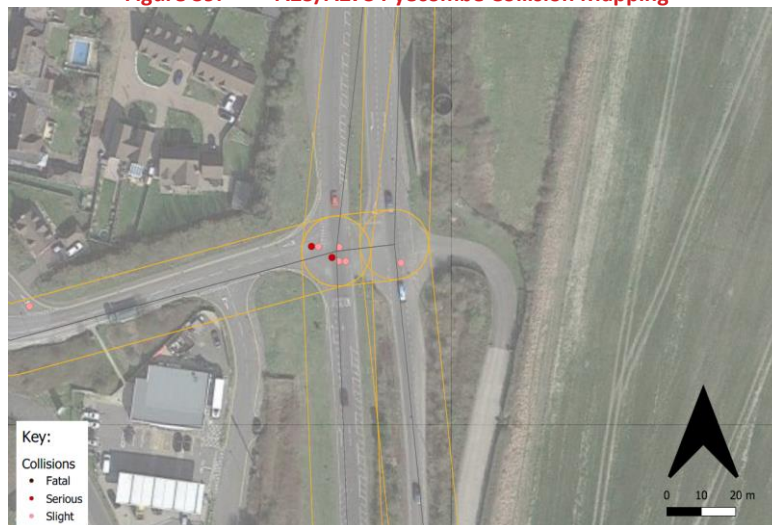
**Figure 39. A23/A273 Pyecombe Collision Mapping**

- 2.11.6 As is evident above, seven collisions are recorded over the seven-year study period. Six of these (Two serious and four slight) took place within the western junction of the node, whereas one collision (slight in severity) took place within the eastern junction.
- 2.11.7 A majority of the collisions are caused by a drivers either disobeying give-way markings, poor turning or manoeuvres or failing to judge oncoming vehicles speed. One of the serious collisions was caused by a vehicle entering the A23 after turning from the petrol station too abruptly.
- 2.11.8 The conditions of the existing junction are indicated in **Figure 40** below.

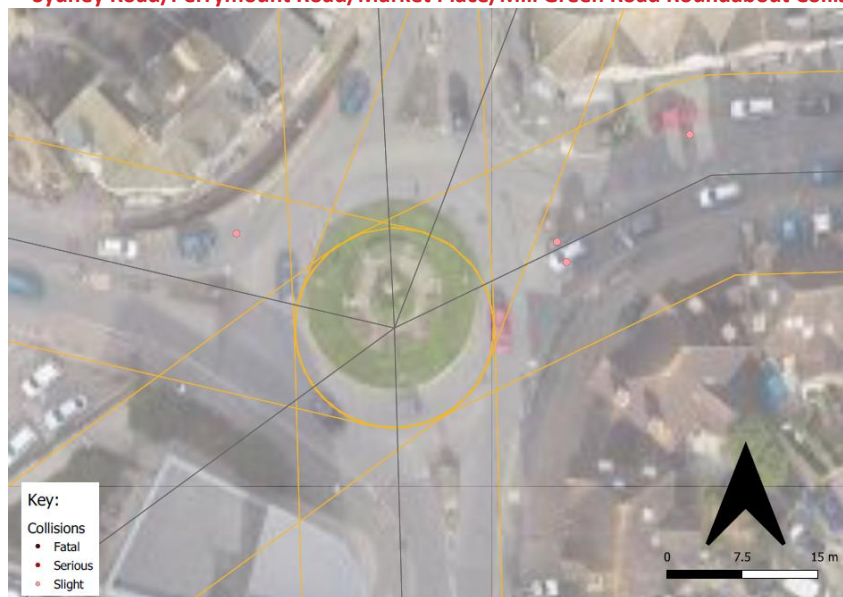
**Figure 42. Sydney Road/Perrymount Road/Market Place/Mill Green Road Roundabout Collision Locations**

2.12.6 As indicated the figure above, three of the four collisions are located to the east of the roundabout, and one at the western entry to the circulatory. There is no discernible causal theme between the collisions.

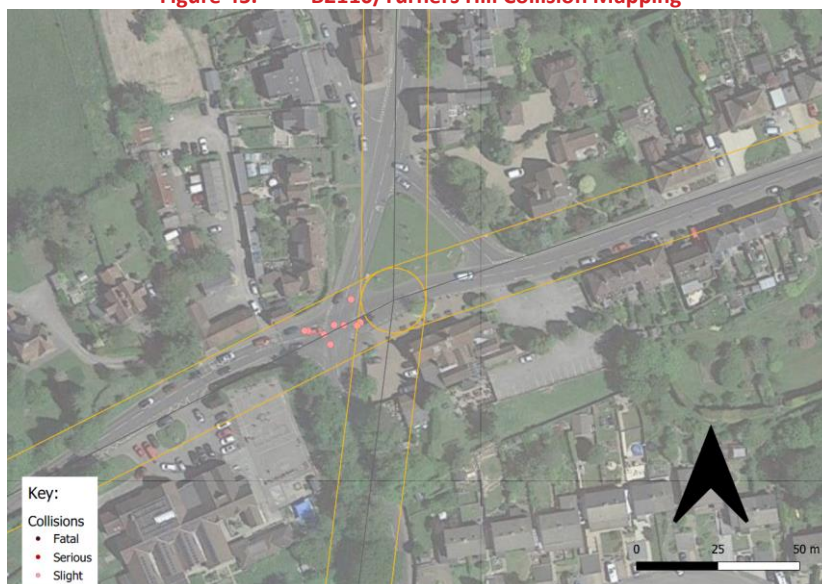
**Figure 45. B2110/Turners Hill Collision Mapping**

2.13.5 As evident from the mapping above, a cluster of collisions occur at the approach arm of the B2110, with four collisions caused by north-south vehicles colliding with east-west vehicles.

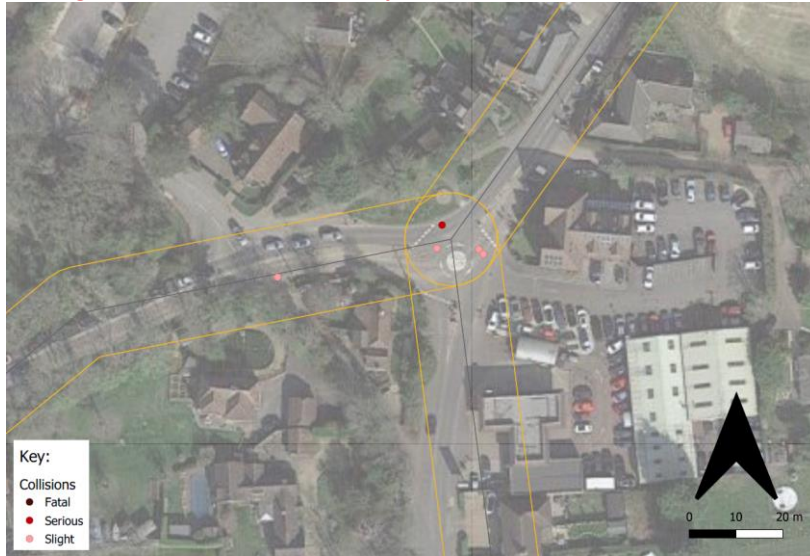
**Figure 48. A272/B2036 Ansty Mini-Roundabout Collision Locations**

2.14.5 As indicated in the table above, a number of the collisions appear to occur by vehicles driving onto the roundabout without observing circulating traffic. Four of the collisions (1 serious and three slight) are noted to take place within the roundabout itself, and one slight collision is noted to occur on the B2036 western approach arm..

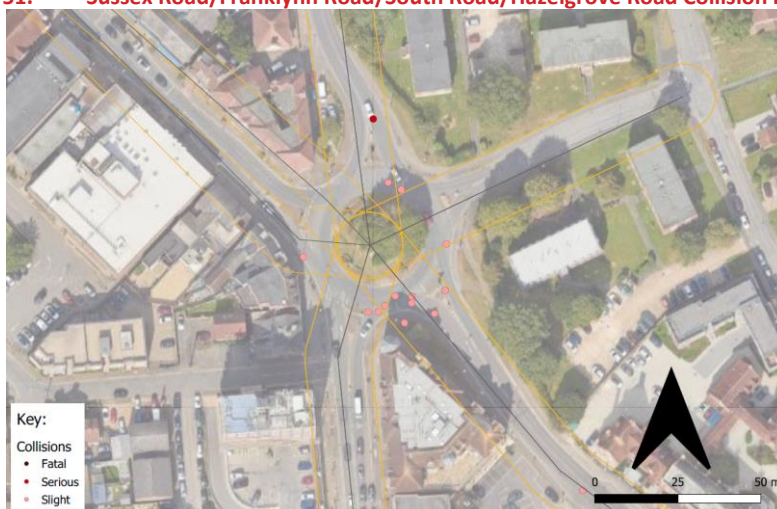
**Figure 51. Sussex Road/Franklynn Road/South Road/Hazelgrove Road Collision Location**

- 2.15.5 As is evident above, eleven of the slight collisions are mapped within the southern region of the circulatory, whereas two slight and one serious collisions occur to the north side of the roundabout.
- 2.15.6 Four of the collisions occurred between vehicles failing to see cyclists upon entry to the roundabout, including the serious collision.

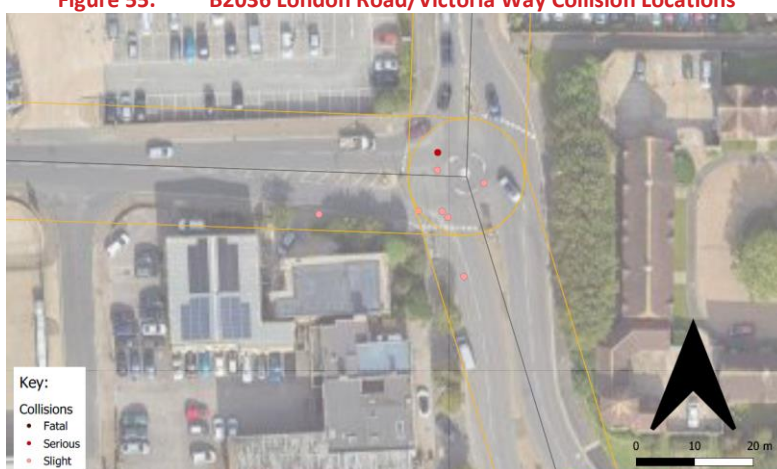
**Figure 55. B2036 London Road/Victoria Way Collision Locations**

2.16.5 As shown above, the majority of the mapped collisions occur within the circulatory (five slight and one serious). One slight collision occurs on the B2036 southern arm, and one on the Victoria Way western arm.
