# MID SUSSEX DISTRICT PLAN

## SAFETY STUDY

<b>Client/Project owner</b>	Mid Sussex District Council
<b>Project</b>	Mid Sussex District Plan
<b>Study</b>	Safety Study
<b>Type of document</b>	Report
<b>Date</b>	30/09/2024
<b>Reference number</b>	GB01T24C55/RPT/01
<b>Number of pages</b>	84

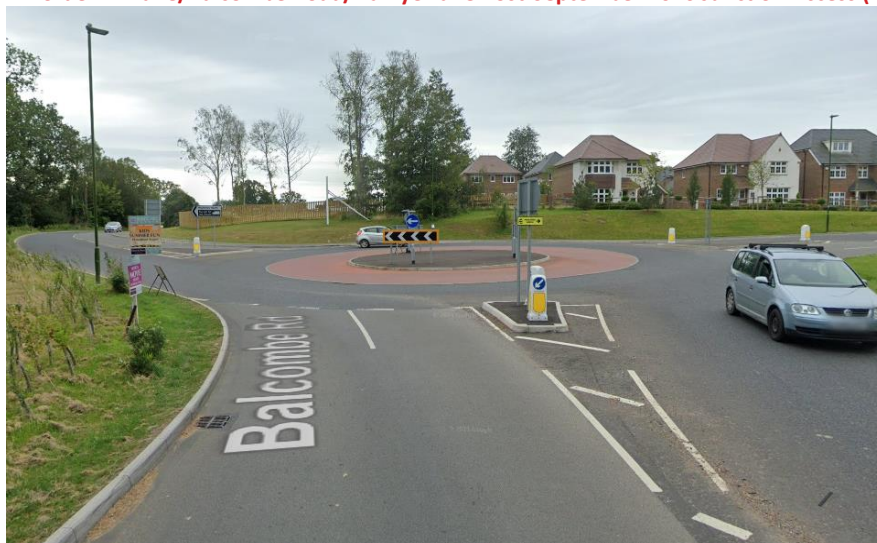
**Figure 4. Borde Hill Lane/Balcombe Road/Hanlye Lane Post-September 2020 Junction Access (Northern Arm)**

2.2.9 Upon closer analysis of the junction layout post-September 2020, it is apparent the arms have wide entries to the roundabout circulatory, and lighting is present around the junction. Whilst all three arms are comprised of two entry lanes, it is noted that along the Borde Hill Lane arm to the north, the lane markings for two lanes stretches approximately four metres in length from the Give Way line allowing for a single car flare. The view from the Balcombe Road arm is indicated in **Figure 4** below, and the lack of signage on the approach arm from Hanlye Lane is displayed in **Figure 5**.

- 2.2.11 Due to the recent upgrade scheme to an unsignalized roundabout in 2020, and the limited physical improvements which are feasible being considered unlikely to have a significant effect upon the observed causes of collisions at the junction, this location has not been taken forward for future mitigation.

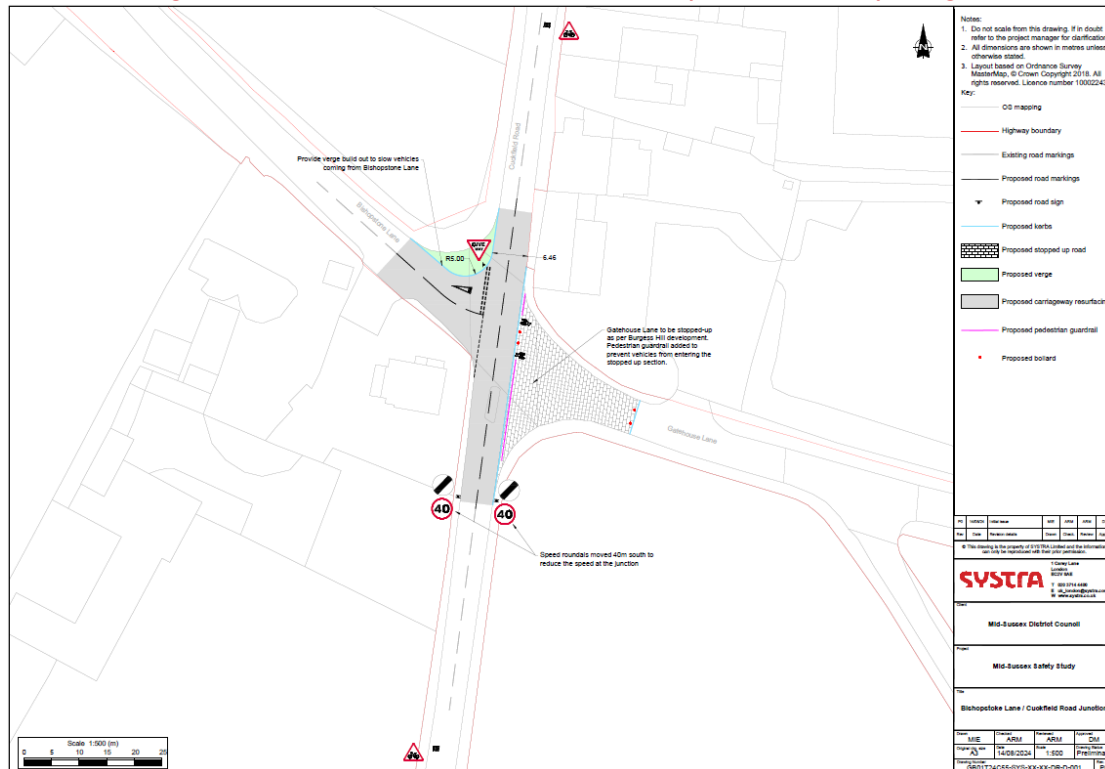
**Figure 10. Cuckfield Road/Gatehouse Lane/Bishopstone Lane Concept Design**

- 2.3.8 As is evident from the figures above the junction is subject to significant degradation, with the southern arm of Cuckfield Road specifically comprised of a narrow entrance to the junction, with faded road markings, and heavily-worn road surfacing.
- 2.3.9 Whilst it is apparent that the road surfacing along Gatehouse Lane and Bishopstone Lane is in better condition than along Cuckfield Lane North and South, visibility to the east and western arms from the north and south arms is limited, as displayed in **Figure 8** above.

2.3.10 With the above information considered, it is determined that this junction should be taken forward for further mitigation. An concept design is shown in **Figure 10** below alongside the drawing in full scale at **Appendix A**. This junction design has built upon the proposals developed as part of the Burgess Hill development application and looked to further enhance the provision for cyclists and associated speed limited reductions.

- **40 mph speed limit roundels have been moved 40 metres south of their existing location to include the entirety of the junction within the speed limit area.** It is intended with this mitigation that vehicle speeds entering the junction will be reduced, subsequently increasing the safety.

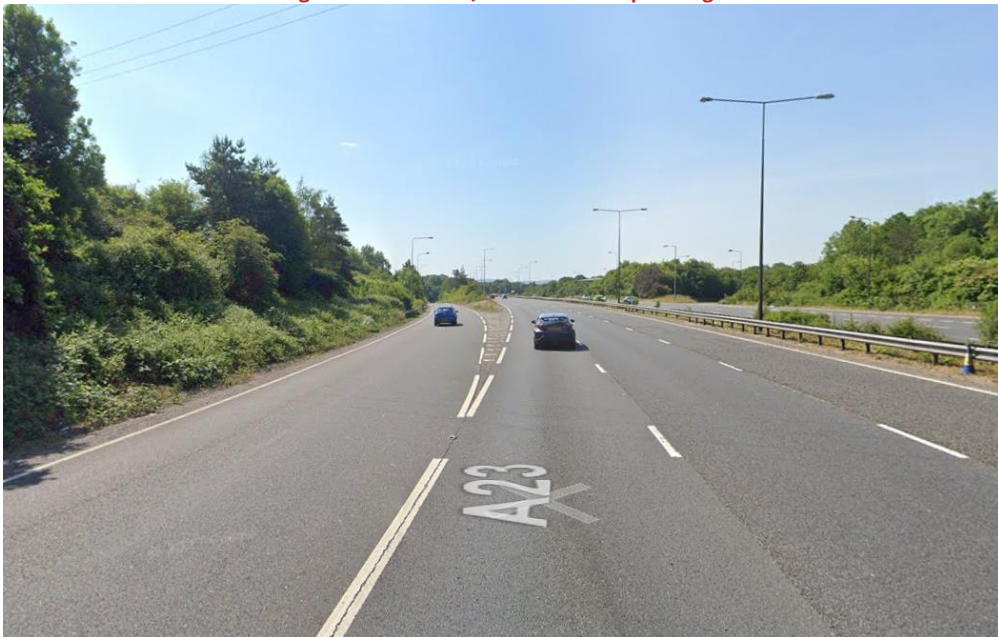
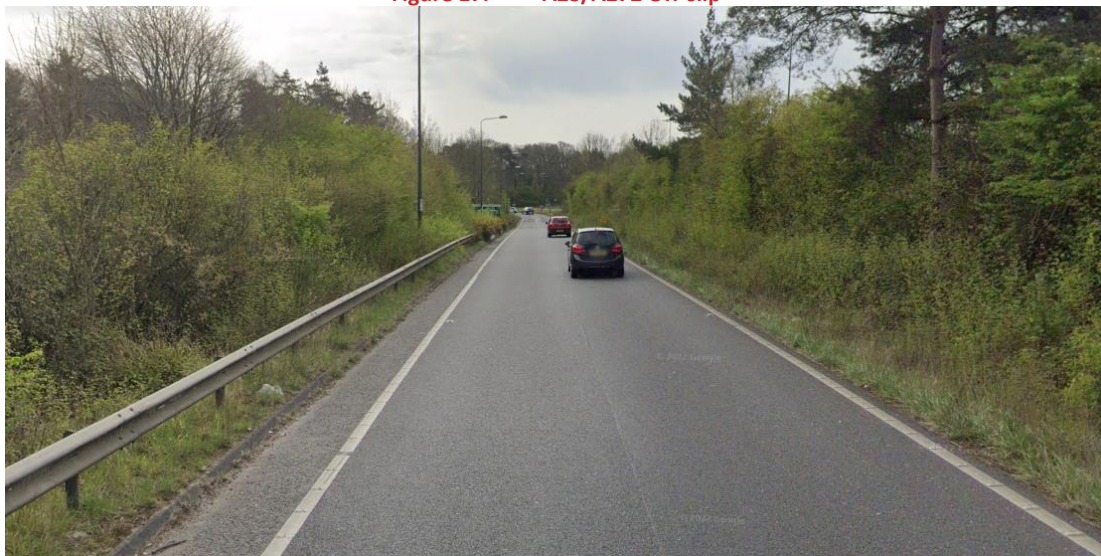
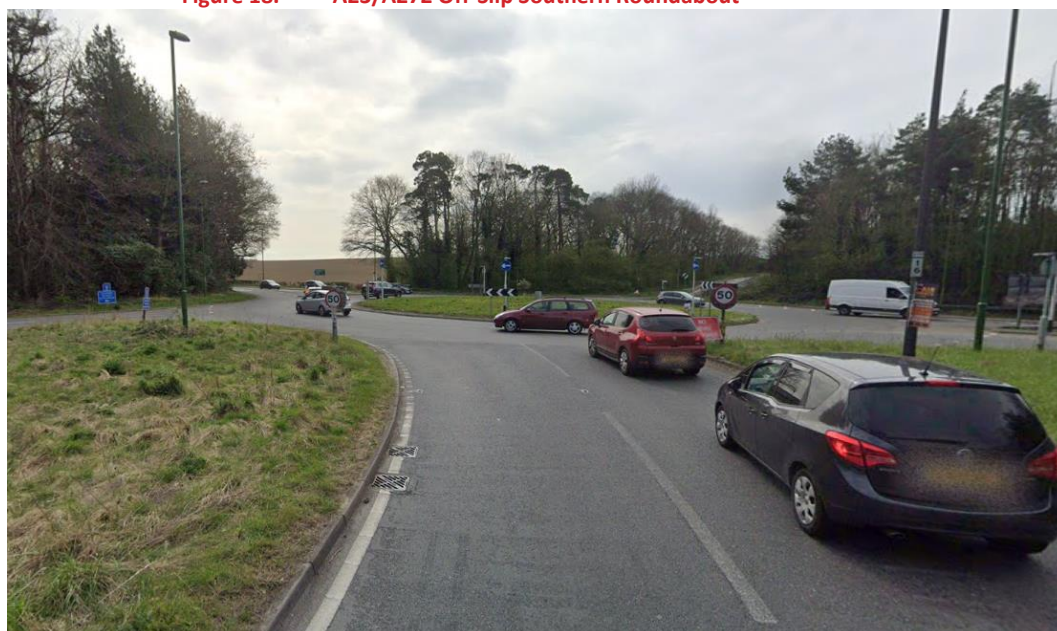
2.5.9 The figures below shown the road layout of the off-slip, with **Figure 16** showing the point of diverge from the A23, **Figure 17** showing the view down the off-slip and **Figure 18** displaying the approach to the roundabout at the southern end of the off-slip.

- 2.5.10 Upon further inspection of the road layout of the off-slip, it is determined that the signage upon approach to the diverge is sufficient however the off-slip is very wide for a single lane at approximately 6.7m. As a single lane this width encourages higher speeds upon approach to the roundabout. The off-slip length and approach to the roundabout at this southern end has a speed limit of 50 mph, with no warning sign on the slip road alerting drivers to the presence of a roundabout at the end of the slip road.

- 2.5.11 It is determined due to the high level of collisions surrounding the off-slip, that it should be taken forward for further mitigation development. **Figure 19** indicates SYSTRA's development option for the off-slip, with a full-scale drawing in **Appendix A**.

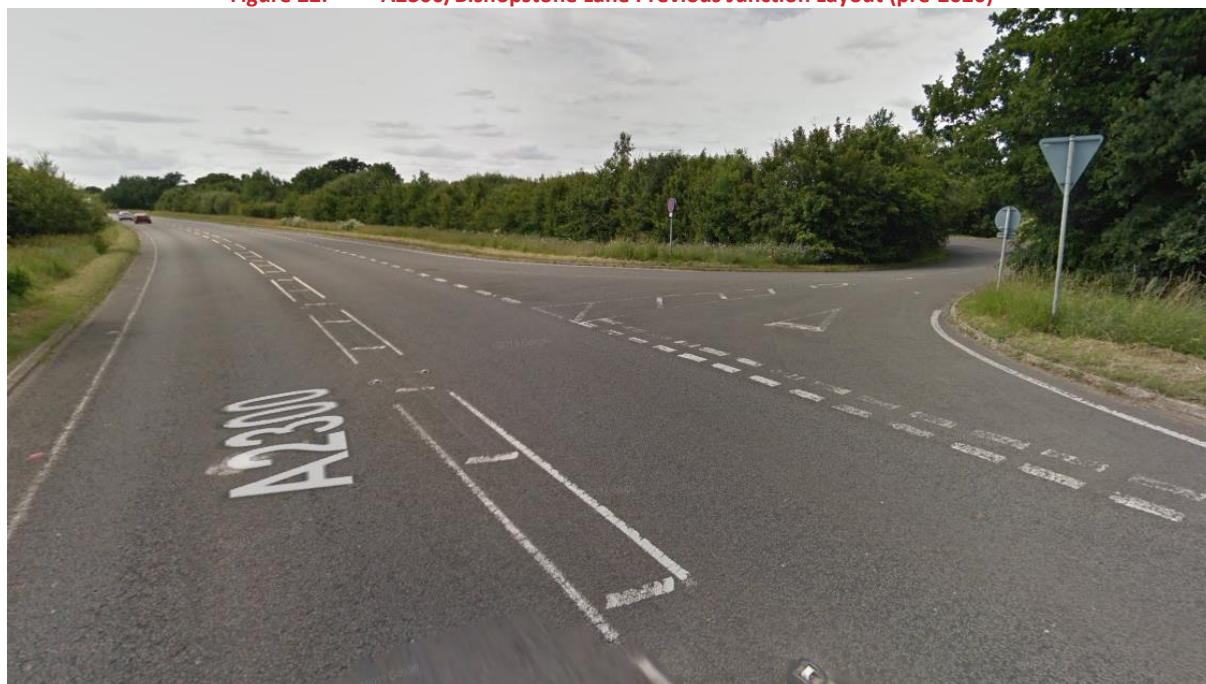
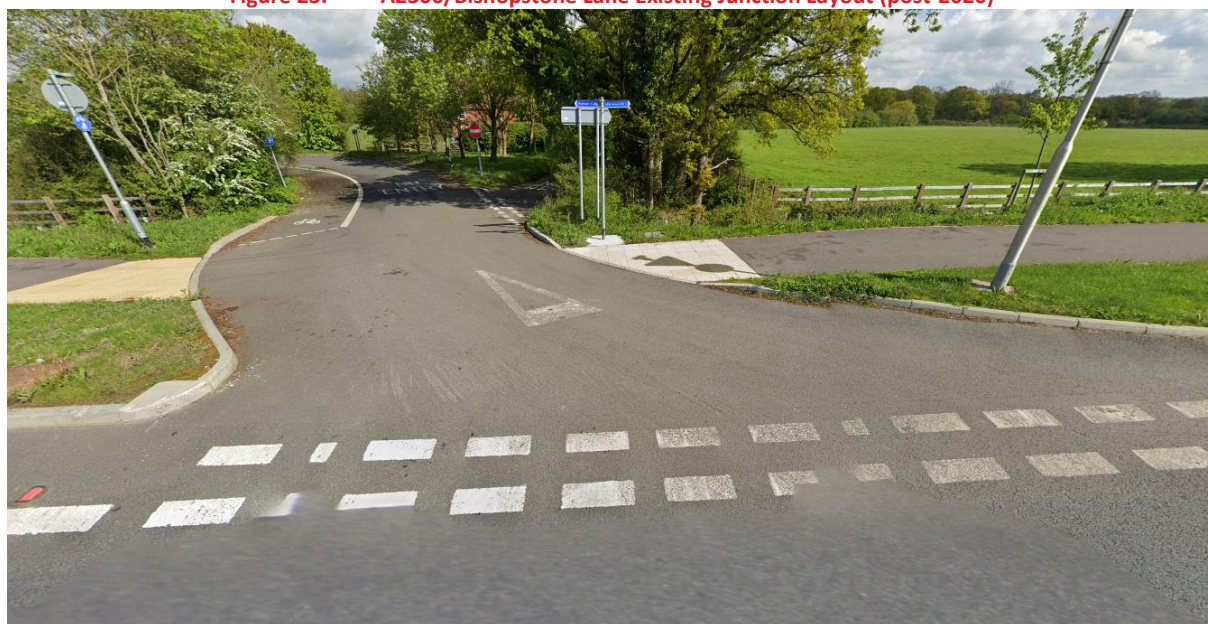
2.6.7 **Figure 22** and **Figure 23** below indicate the previous and existing layout of the junction.

2.6.8 As is evident from the figures above, with the newly constructed junction layout, Bishopstone Lane is not accessible from the A2300, and therefore the risk from previous collisions is not considered to justify further mitigation assessment as the conflict points have been addressed by the constructed upgrade.

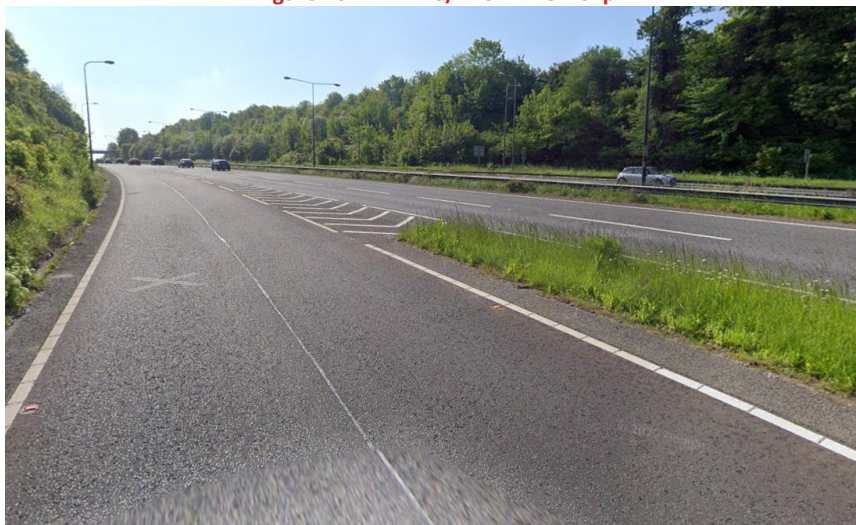
**Figure 26. A23/A281 EB On-Slip**

- 2.7.9 As is evident from the figure above and wider analysis of the merge, it is evident that the road layout is of a sufficient width at 5.8 metres at the beginning of the merge, with the length of the merge being approximately 230 metres.

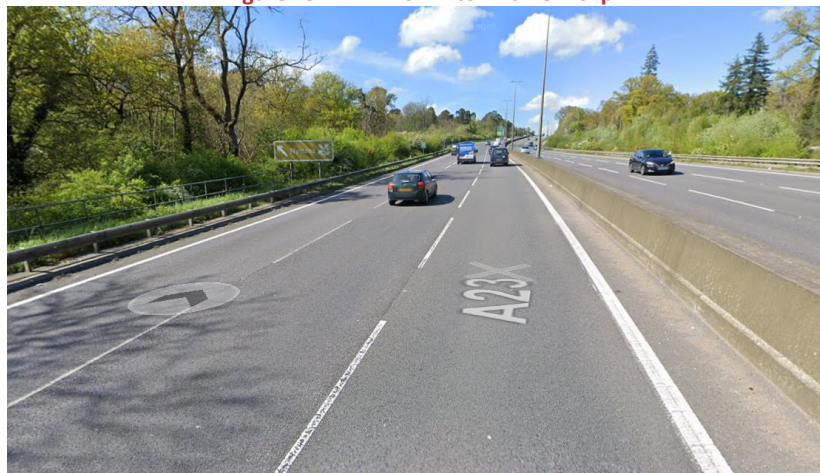
**Figure 29. A23 NB to A264 Off-Slip**

- 2.8.8 The highway quality of the link is considered to be acceptable relative to its role, with three lanes and smooth surfacing quality.

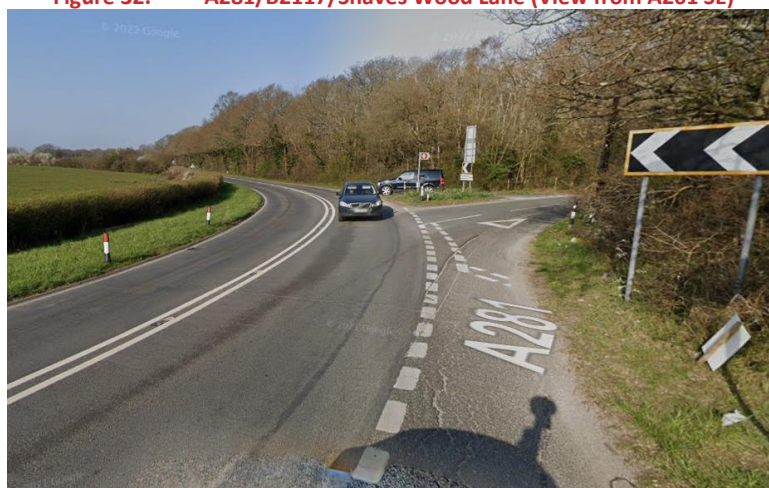
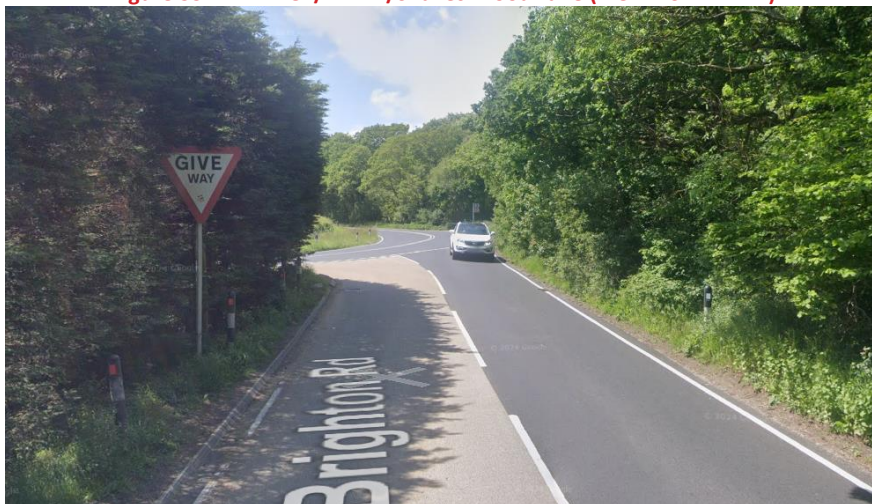
- 2.9.9 As is evident from above, particularly from the B2117, visibility surrounding the junction is poor, with tall and dense trees surrounding the B2117, leading to difficulty in seeing oncoming vehicles from the southeast of the junction. Whilst the cutting back/ removal of the trees would improve junction visibility, it is unlikely that this will fully resolve the visibility issues given the narrow buffer to the highway boundary extent.

- 2.9.10 Due to the high number of collisions and lack of visibility surrounding the junction, it is deemed that the A281/B2117/Shaves Wood Lane junction should be taken forward for further mitigation. The concept design is indicated in **Figure 34** below, and a full-scale drawing in **Appendix A**.

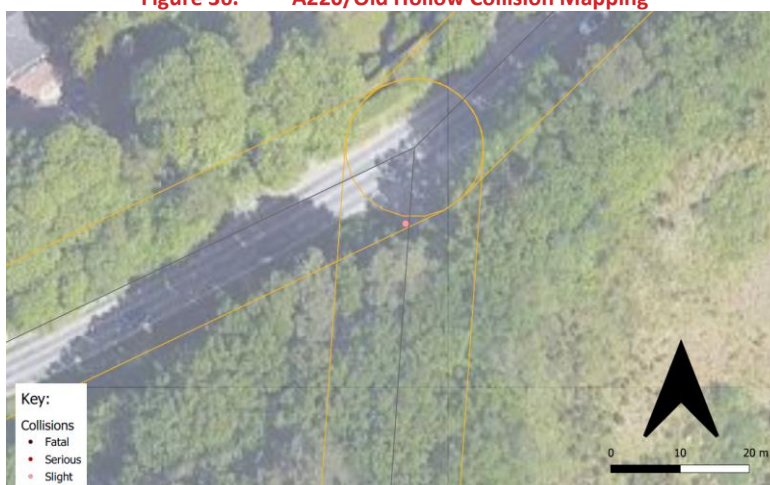
**Figure 36. A220/Old Hollow Collision Mapping**

2.10.5 The collision is noted to occur to the south of the junction along Old Hollow in close proximity to the node.

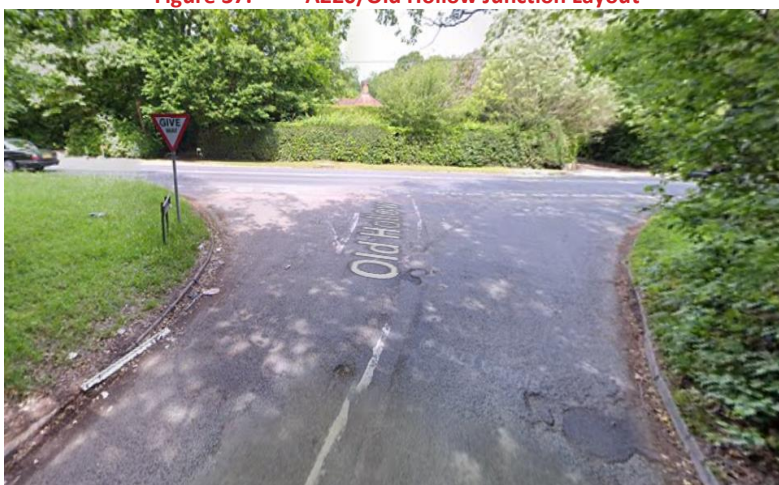
**Figure 37. A220/Old Hollow Junction Layout**

2.10.7 As is indicated above in **Figure 37** above, the junction shows slight surface degradation along the Old Hollow Road arm. However, the lane entries are wide, with adequate visibility and Give Way signage is present.

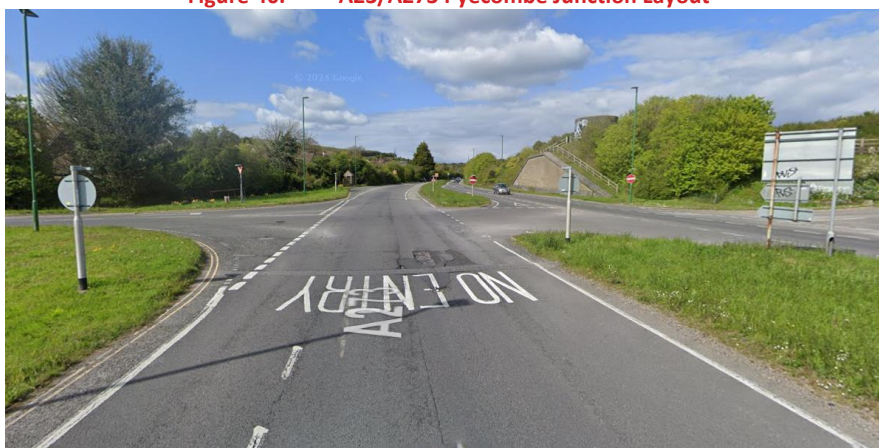
**Figure 40. A23/A273 Pyecombe Junction Layout**

- 2.11.9 As depicted above, the junction is an unsignalized four arm crossroads, with a large central reserve waiting space in between the north and southbound arms of the A23. The road surfacing is smooth, however the painted lanes are faded in areas.

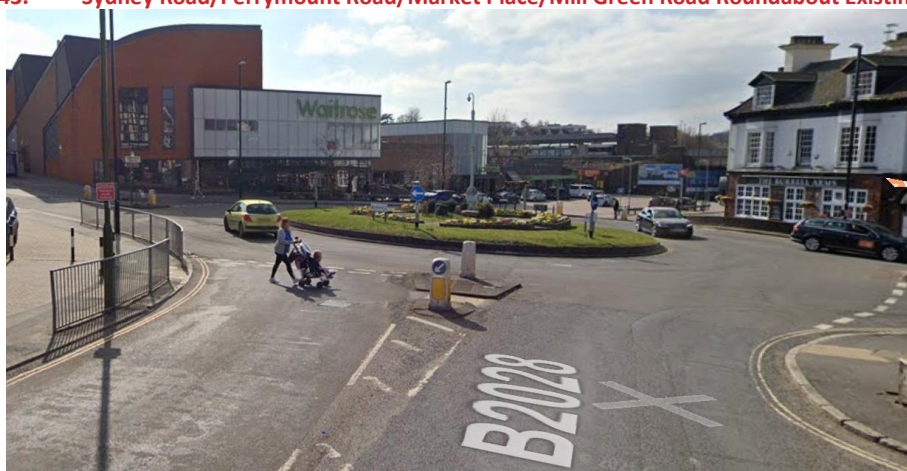
**Figure 43. Sydney Road/Perrymount Road/Market Place/Mill Green Road Roundabout Existing Layout**

2.12.8 As is evident from the image above, the junction has smooth road surfacing and wide approach entry arms and roundabout circulatory. There are no immediate concerns arising from the current junction design and its relationship to the recorded incidents.

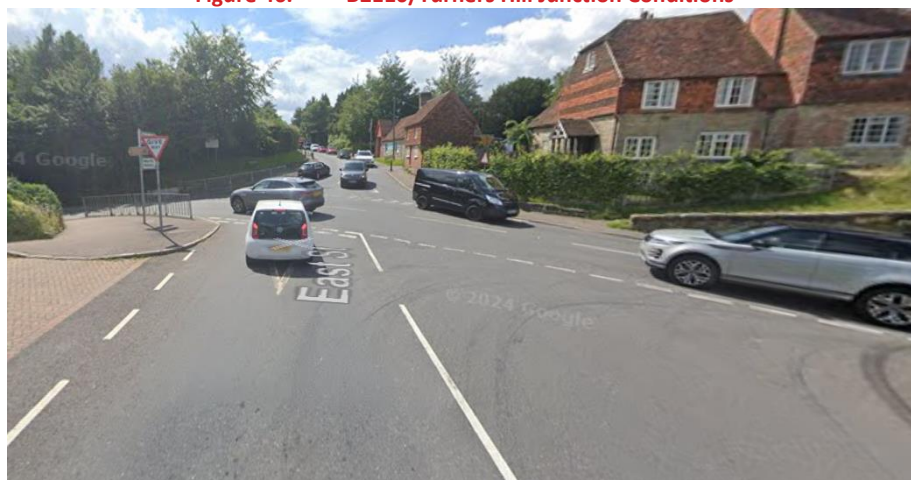
**Figure 46. B2110/Turners Hill Junction Conditions**

2.13.7 As displayed in the image above, the B2110/Turners Hill junction is an unsignalized cross roads with smooth road surfacing and clear lane markings.

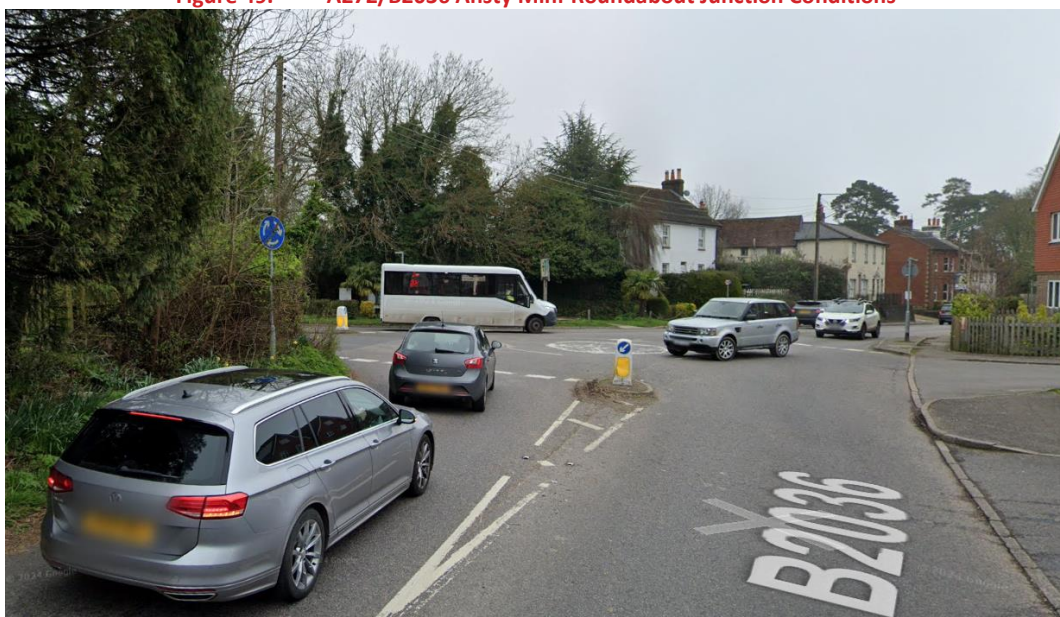
**Figure 49. A272/B2036 Ansty Mini-Roundabout Junction Conditions**

- 2.14.7 As indicated in **Figure 49** above, the A272/B2036 Ansty mini-roundabout is noted to be comprised of a single lane entry on each of the approach arms. Signage is present at the entry to the roundabout to indicate the circulatory.

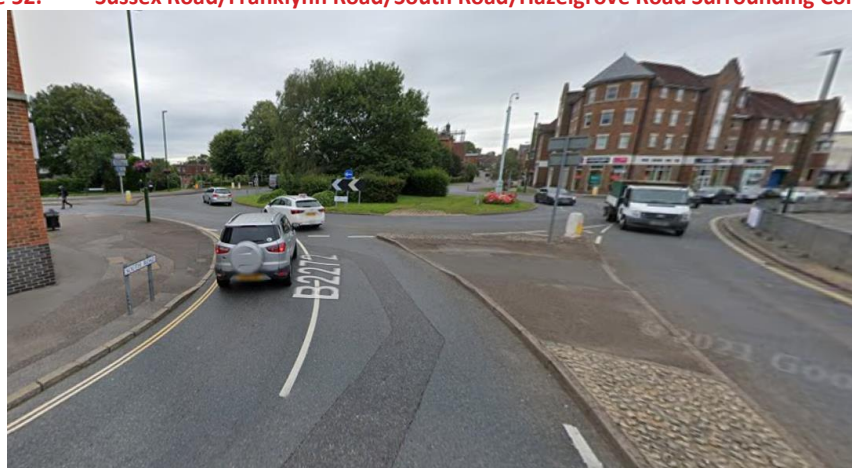
**Figure 52. Sussex Road/Franklynn Road/South Road/Hazelgrove Road Surrounding Conditions**

- 2.15.8 As is indicated above, the junction features smoothed road surfacing with the B2272 (west) and B2112 (north) having two lanes marked but no directional lane markings. There is a noted lack of pedestrian/cyclist provision, including no tactile paving on the uncontrolled pedestrian crossings despite the roundabout being located in any area of high footfall at the southeastern end of the local high street on B2272.

- 2.15.9 Due to the high number of collisions, several of which involved cyclists and vehicles colliding, this junction has been taken forward for mitigation development. Given the town centre location, consideration for improvement for pedestrians in light of the high potential footfall has been factored.
- 2.15.10 SYSTRA's concept design is indicated in **Figure 53** below, with a full-scale drawing presented in **Appendix A**.

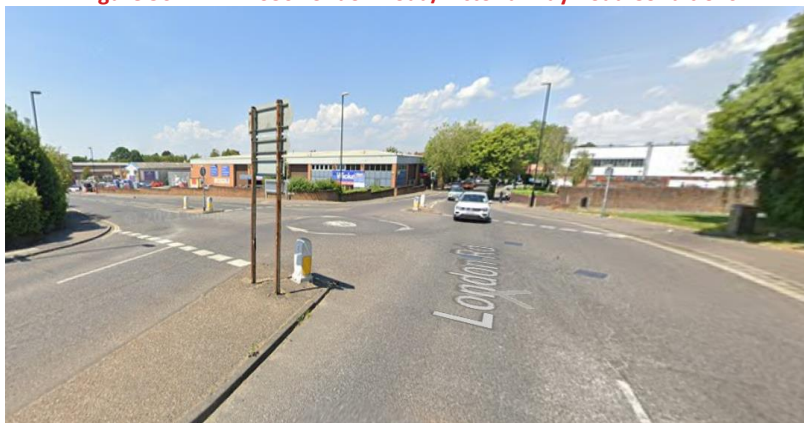
**Figure 56. B2036 London Road/Victoria Way Road Conditions**

2.16.7 It is indicated above the roundabout features smooth road surfacing and high level of visibility across the arms. Each arm of the roundabout has two approach lanes with no lane destination arrows.

2.16.8 Due to the high number of recorded collisions, included conflict with vehicles and cyclists, this junction has been taken forward for mitigation development. SYSTRA’s proposed concept design is shown in **Figure 57** below and within **Appendix A**.

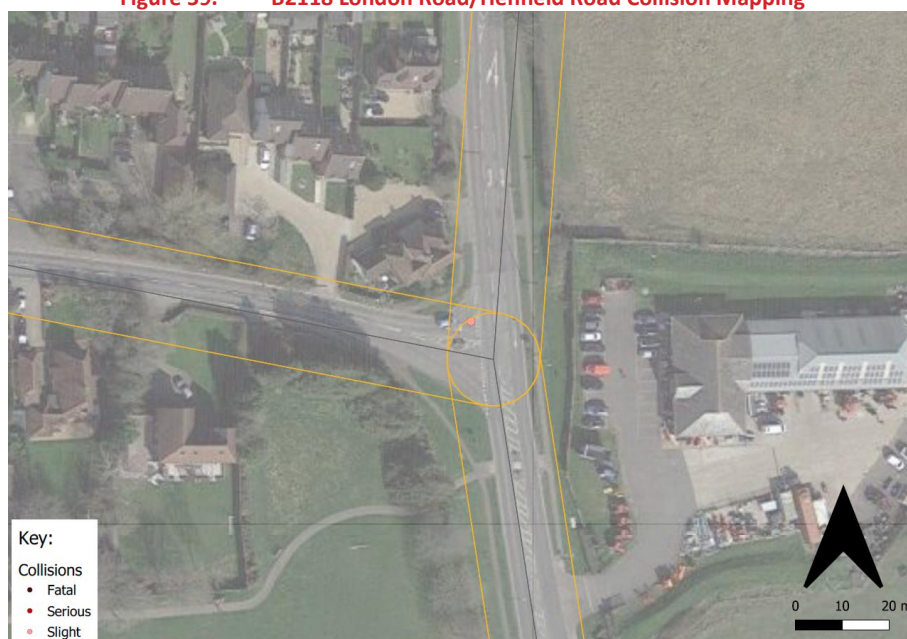
**Figure 59. B2118 London Road/Henfield Road Collision Mapping**

2.17.6 The collision was the result of the vehicle pulling out of Henfield Road and colliding with a northbound vehicle traveling along London Road.

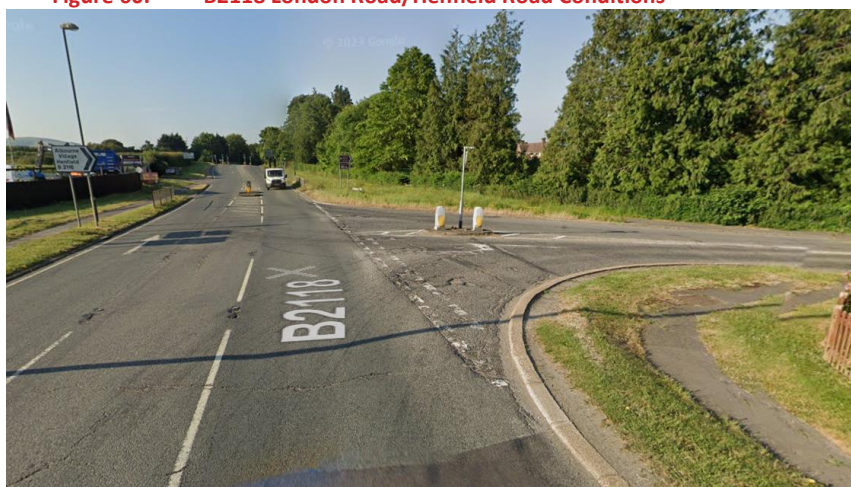
**Figure 60. B2118 London Road/Henfield Road Conditions**

- 2.17.8 As indicated above, the junction has wide radii with Henfield Road arm subject to significant wear, with faded road markings.

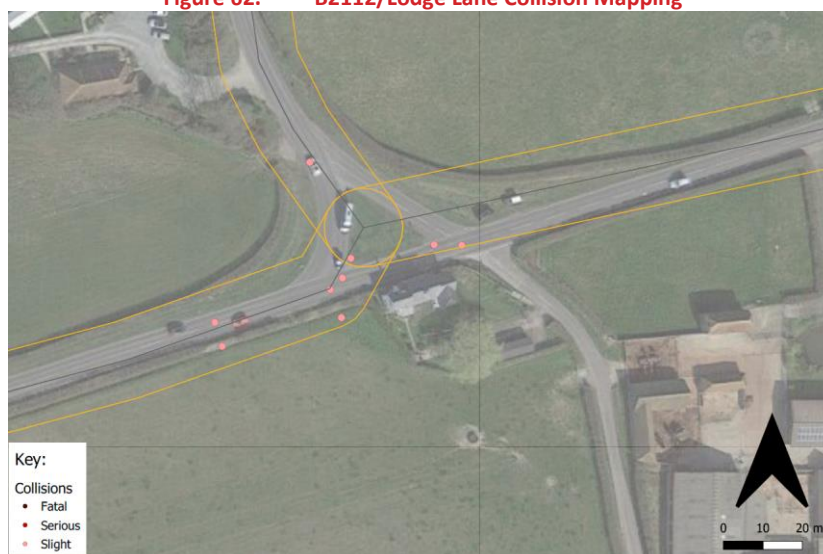
**Figure 62. B2112/Lodge Lane Collision Mapping**

2.18.5 As indicated above, six of the mapped collisions are noted to have occurred to the west of the junction, two to the east and one to the north. A high proportion of collisions are noted to have occurred as a result of vehicles pulling out of Lodge Lane and misjudging the amount of time available for exiting before colliding with oncoming traffic.

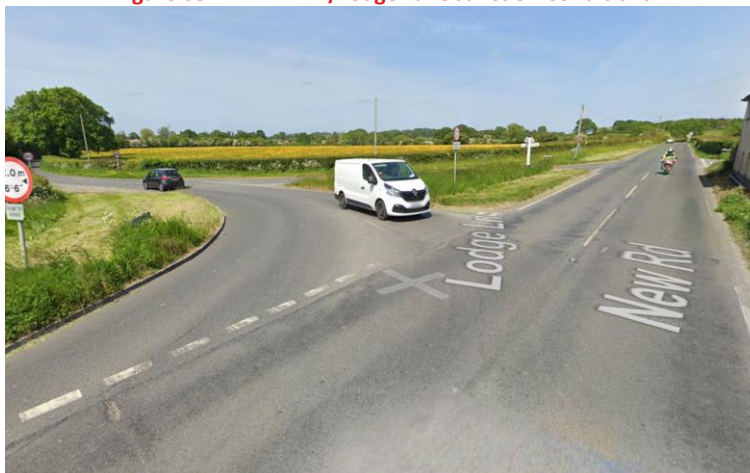
**Figure 63. B2112/Lodge Lane Junction Conditions**

2.18.7 As indicated above, the forked arrangement of the junction results in several potential turning movements in close proximity from each of the minor arms.

2.18.8 The causation factors indicate that the collisions are not a result of the junction layout but rather a failing of drivers to look properly and misjudgement of gaps and time available for vehicles to turn. This junction has therefore not been taken forward for mitigation development.

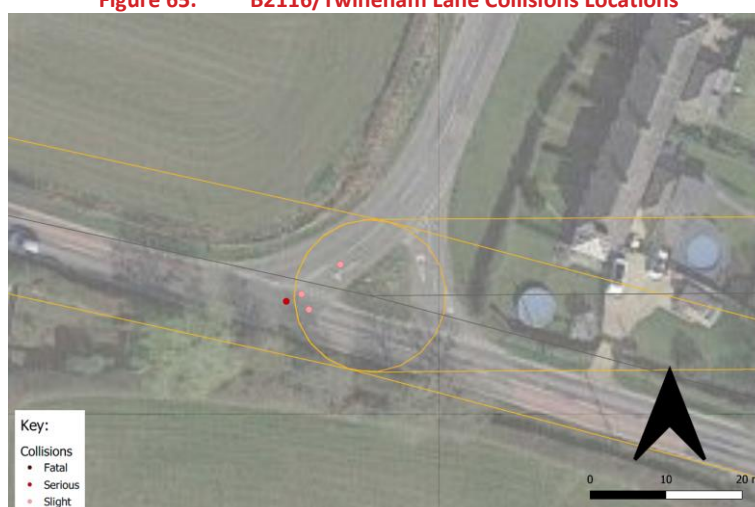
**Figure 65. B2116/Twineham Lane Collisions Locations**

2.19.4 The location of the collisions surrounding the B2116/Twineham Lane junction is indicated in **Figure 65** below. It should be noted that two of the collisions overlap in the image below as they are mapped to the same location.

- 2.19.5 As indicated above, all of the collisions occur toward the western fork of Twineham Road and its merge with the B2116.
- 2.19.6 The conditions surrounding the junction are indicated in **Figure 66** below.

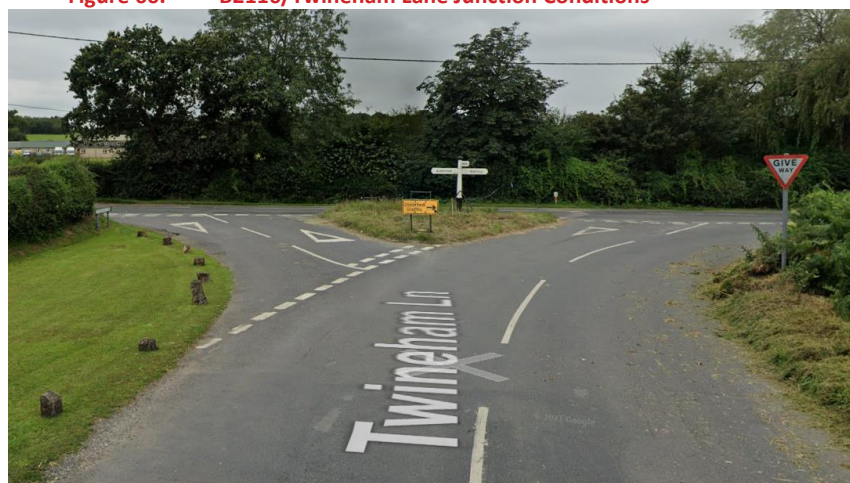
**Figure 66. B2116/Twineham Lane Junction Conditions**

- 2.19.7 As seen above, the junction features widened lanes with clear road markings and Give Way signage. It is notable that the eastern fork of Twineham Lane is short, at a length of approximately 12 metres.

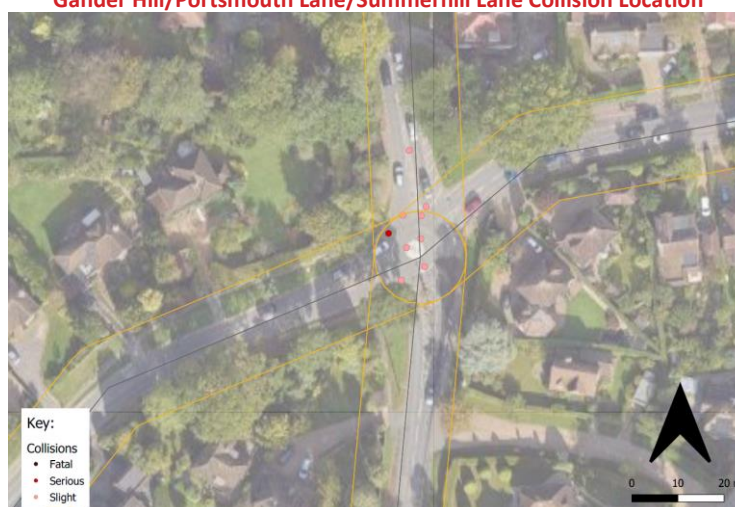
**Figure 68. Gander Hill/Portsmouth Lane/Summerhill Lane Collision Location**

2.20.5 As evidenced above, eight of the collisions are mapped to occur within the junction, with one occurring on the Portsmouth Lane on approach to the junction from the north.

2.20.6 A high proportion of the collisions occur as a result of vehicles failing to see oncoming vehicles from other arms when entering the roundabout.

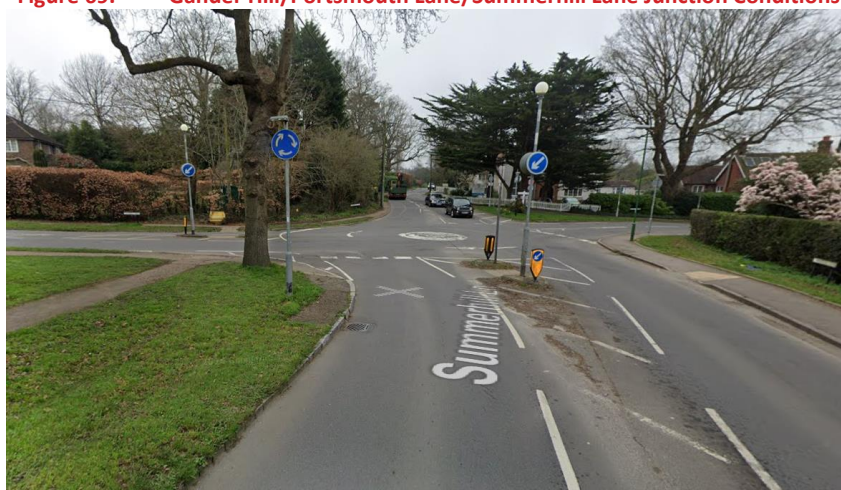
**Figure 69. Gander Hill/Portsmouth Lane/Summerhill Lane Junction Conditions**

2.20.8 As shown above, the roundabout is comprised of single lanes entering the circulatory and has adequate signage and visibility. It is noted that a high proportion of collisions occurred as a result of driver error rather than any notable trends associated with the physical junction layout

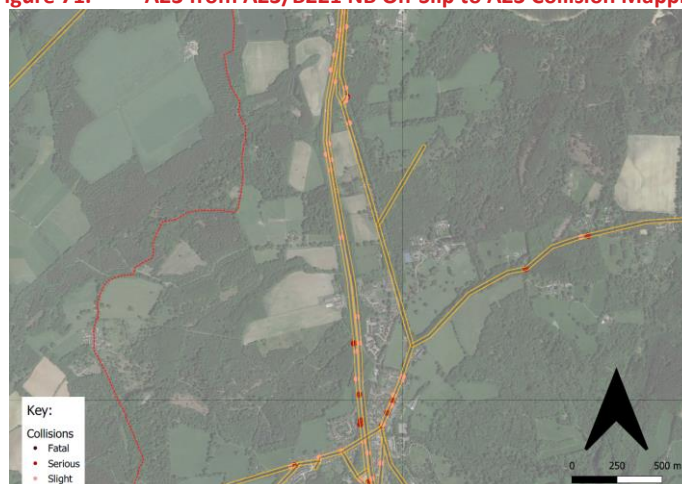
**Figure 71. A23 from A23/B221 NB On-Slip to A23 Collision Mapping**

2.21.5 As is evident above, the collisions within the seven-year study period occur relatively evenly throughout the length of the link, with the largest cluster in close proximity to the B221 On-Slip to the south.

2.21.6 A high proportion of the collisions are associated with driver error. There is limited commonality between the causation of the collisions, however two are the result of wet conditions.

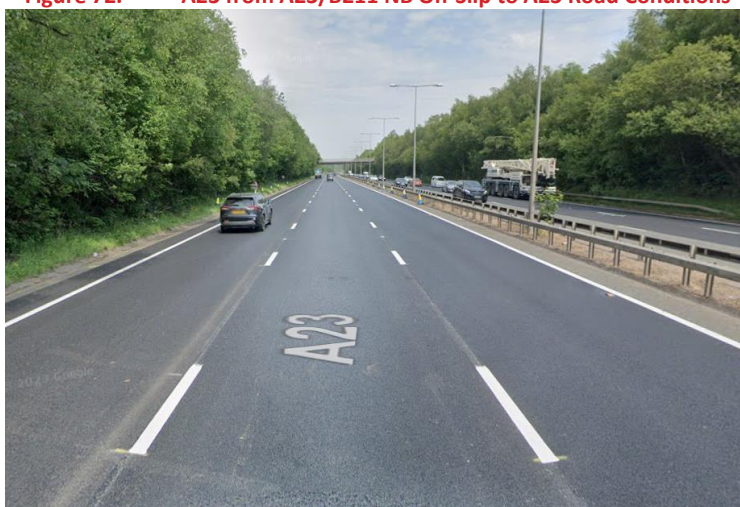
**Figure 72. A23 from A23/B211 NB On-Slip to A23 Road Conditions**

2.21.8 As indicated above, the conditions surrounding the link are suitable, with smooth road surfacing, clear lane markings and frequent street lighting.
